Manhole Inspection Summary

Manhole # S31GG2013MH

Location Address: **100 LAKE AVE**

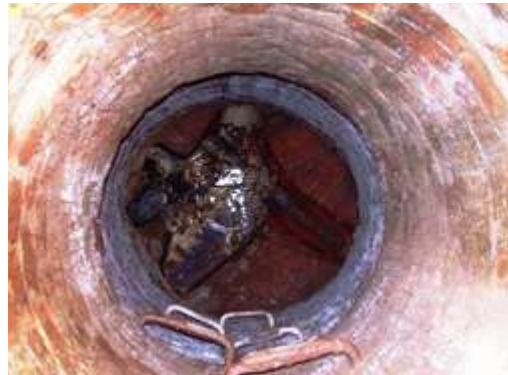
Top View

Adjustment and Corbel infiltration.
Corroded steps. Evidence of surcharge -
Bench debris. Channel debris.

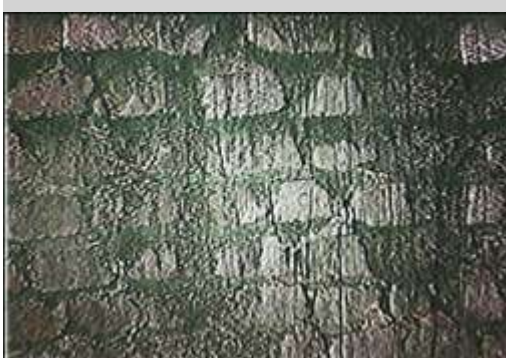
Defect

Barrel deterioration and infiltration.

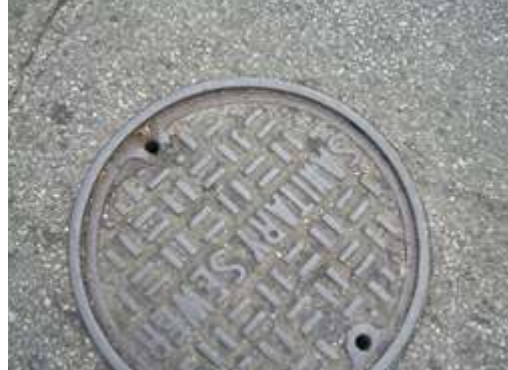
Defect

MH cover subject to ponding.

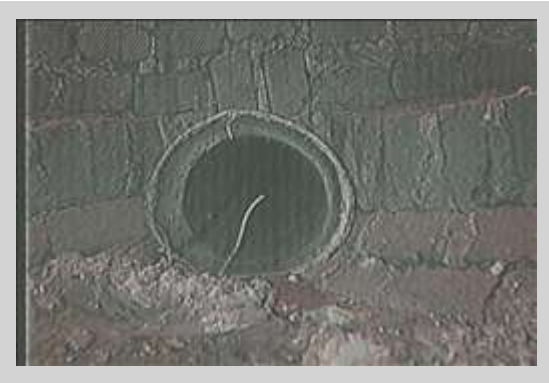
8 in. Circular Gravity Sewer Pipe Out @ 12 O'Clock

Barrel deterioration and infiltration. Channel deterioration and root intrusion.

Infiltration: **None** Pipe Seal Cond: **Cracked**

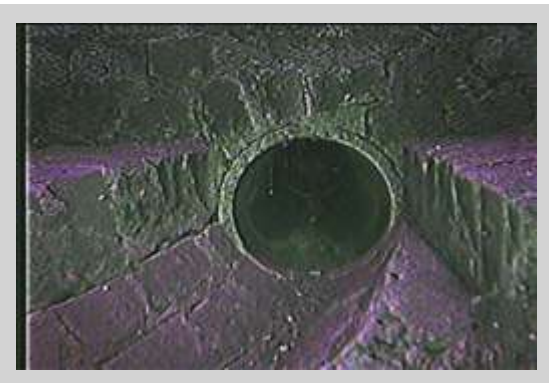
8 in. Circular Gravity Sewer Pipe In @ 4 O'Clock

Channel deterioration.

Infiltration: **Evidence** Pipe Seal Cond: **Cracked**

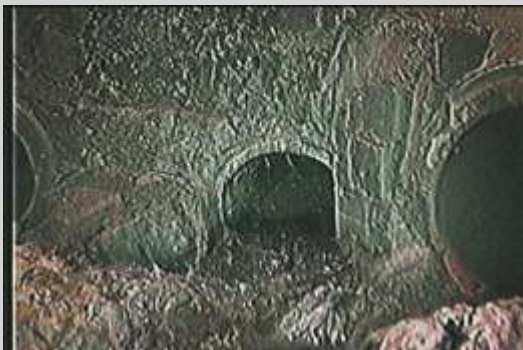
Pipe In @ 8 O'Clock

Channel debris.

Deposits: ☐ None ☒ **Mud** ☐ Sludge ☒ **Debris** ☒ **Grease**
